Bank Stabilization at Vess Soda

City of Maryland Heights, Missouri

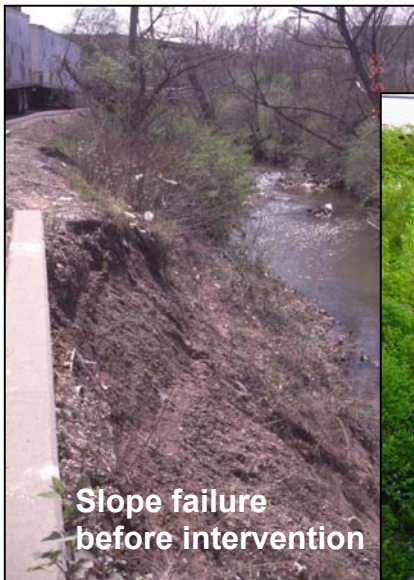
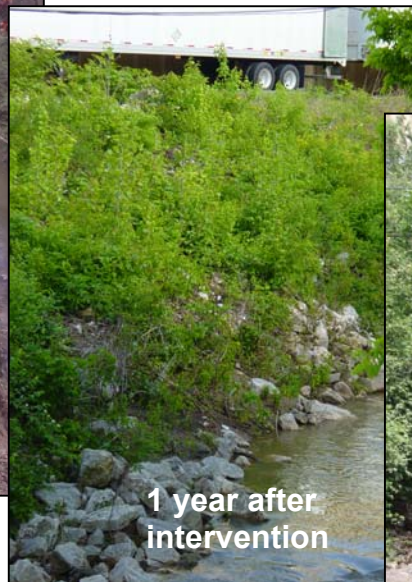
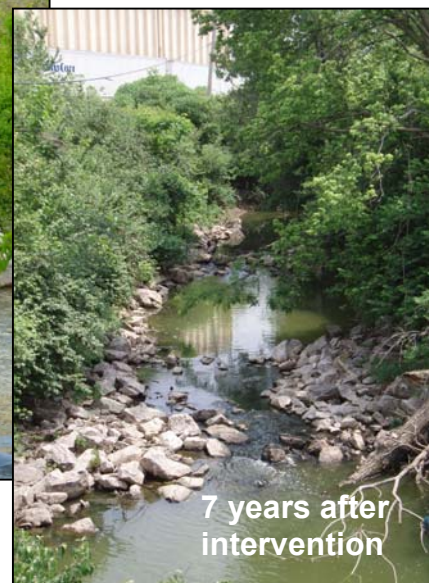
Channel incision led to the failure of the right descending bank and undermined the bridge piers at the Vess Soda site. The site was particularly challenging because it is paved to the top of the streambank and the side slopes are steep (about 1:1). These factors combine to produce an exceptionally dry, drought-prone project site that would generally be considered unsuitable for soil bioengineering stabilization.

We addressed both the slope failure and stream instability undermining the bridge by designing in-stream grade control structures to dissipate erosive energy and focus the flow under the bridge and away from the piers. The slope was stabilized using a composite revetment, reinforced with horizontal layers of structural geogrid. The plant palette for this site relied on drought tolerant species, such as *Amorpha fruticosa* (False indigo). The site was not well maintained during the first growing season and has received no maintenance since installation in February of 1999. Nevertheless, the vegetation is well established and growing vigorously. The root gel used on the plant roots contains humic acid, kelp, vitamin B and naphthalene acetic acid to reduce transplant shock, as well as hydrophilic gel for water retention.
