Restoration of Wildhorse Creek

City of Wildwood, Missouri

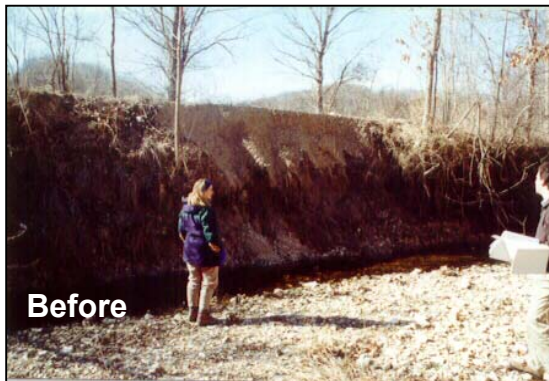
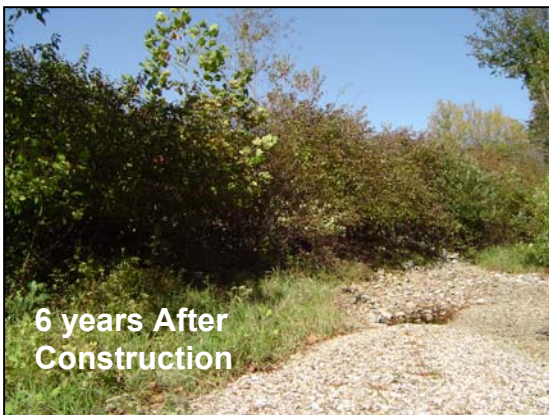
At the Hardt Road and Ossenford Road sites, we used a series of rock grade controls to guide the flow through the center of the reach and to dissipate the considerable stream energy. Banks were restored using composite revetment planted with native riparian plants. Both Hardt and Ossenford Road

were under imminent threat and required immediate repair. This restoration design eliminated the threat without harming the Wildhorse ecology or fluvial process.
