Lackland Bridge Mitigation

City of Maryland Heights, Missouri

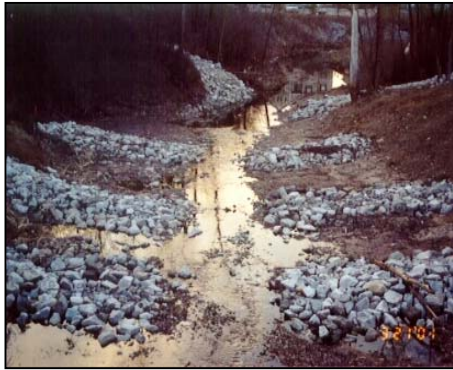
The Lackland Bridge site is located on a reach of the East Tributary to Fee Fee Creek and was evaluated as part of a comprehensive examination of the Fee Fee Creek Watershed. Geomorphologic analysis, including a longitudinal profile survey, indicated that the reach is stable with the exception of several hundred feet on either side of the recently installed Westport V Bridge (a double 12-foot X 12-foot box culvert). Incision upstream of the bridge has induced slope failure when banks exceed critical height and the subsequent liberation of sediment into the stream.

Two grade controls were installed upstream of the bridge to control the incision and to help direct flow through meanders. Six in-stream weirs and one grade control were installed downstream of the bridge to re-establish the low flow channel and help with bank stability by taking erosive pressure off the streambanks. During low flows, the entire flow is contained in the center of the channel between the weirs. During higher flows, the weirs direct the high velocity flow to the center of the channel thereby keeping the high velocity away from the bank. The downstream grade control was designed to facilitate the last riffle and direct flow off the site in a controlled manner to reduce potential downstream damage.
